PROPERTY INSPECTION REPORT

John Doe
Doe John

1023 Twig Blvd

5/20/2022

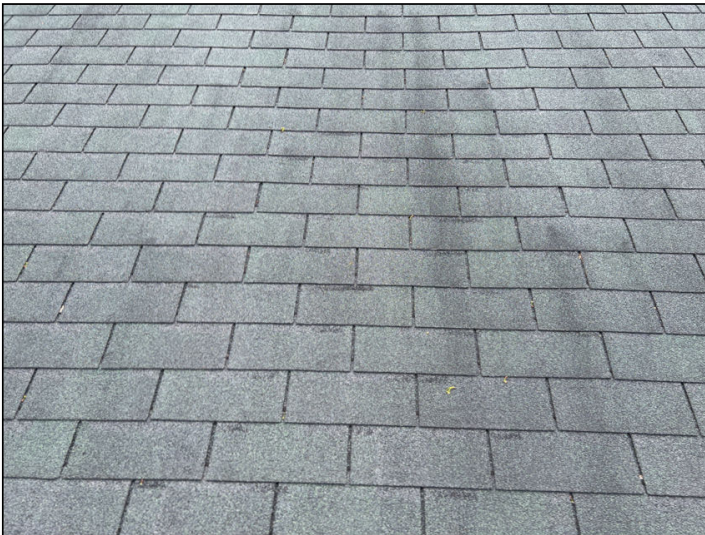
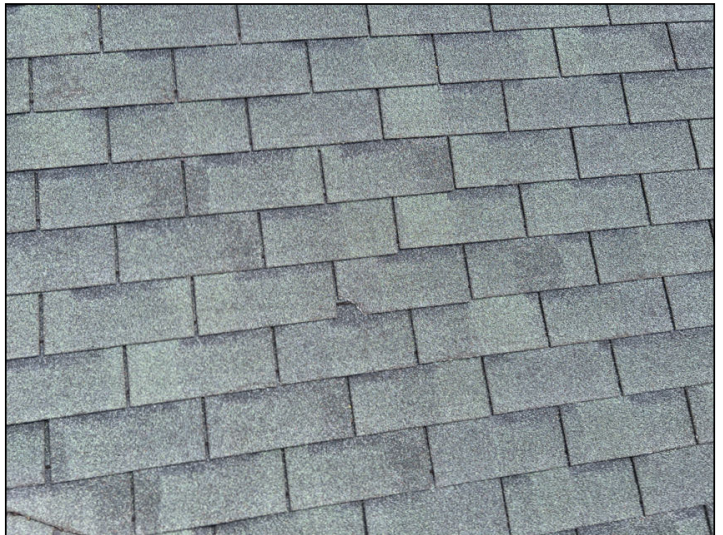
The shingles showed signs of granular loss. This happens with normal wear, shoveling, or walking on the roof surface. The shingles deteriorate faster due to the asphalt substrate being exposed to the elements.

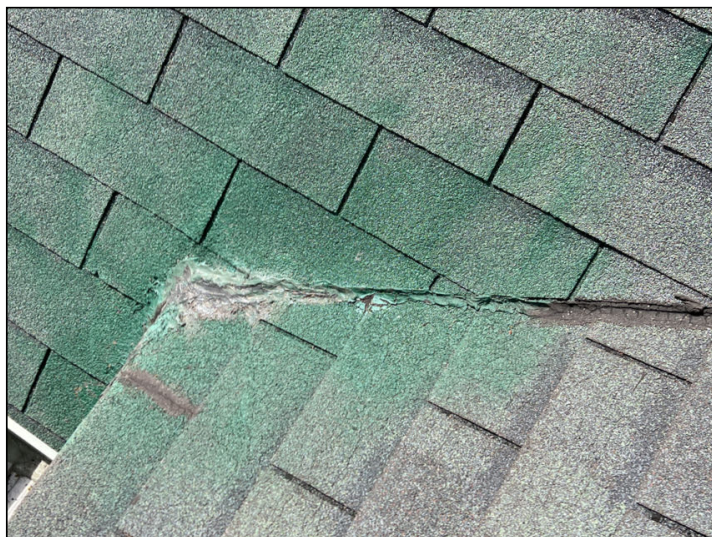
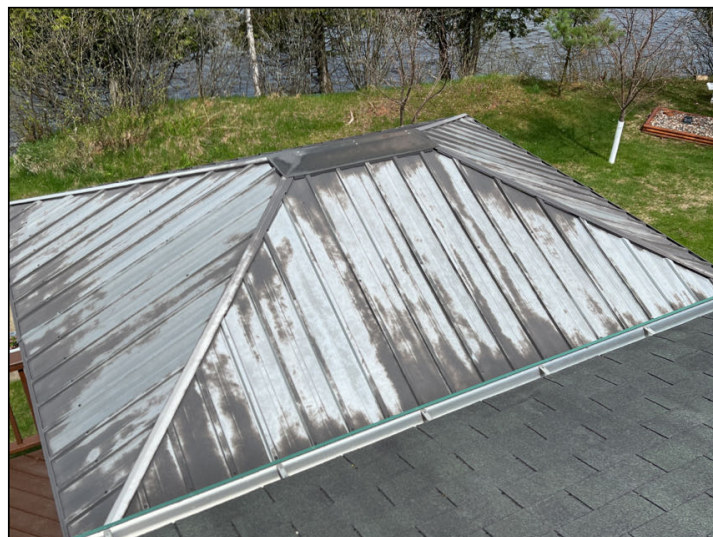
Flex seal/roofing tar was visible in some areas.

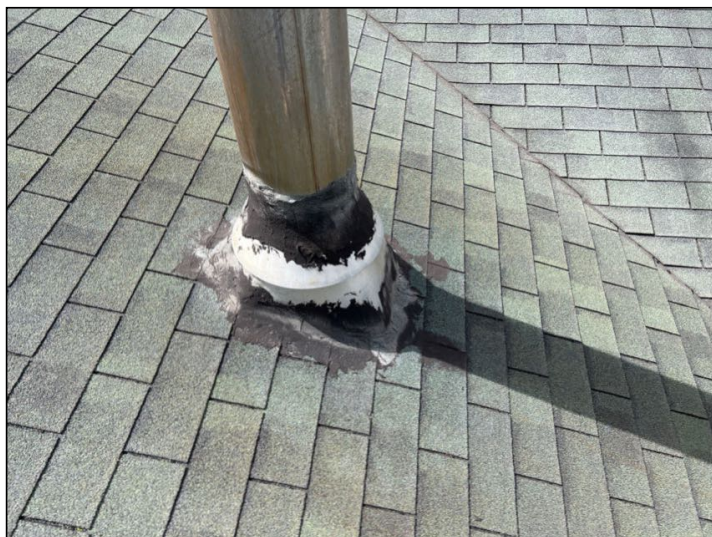
Flex seal/roof tar noticed at roof penetrations. Maintenance may be required to prevent leaks.

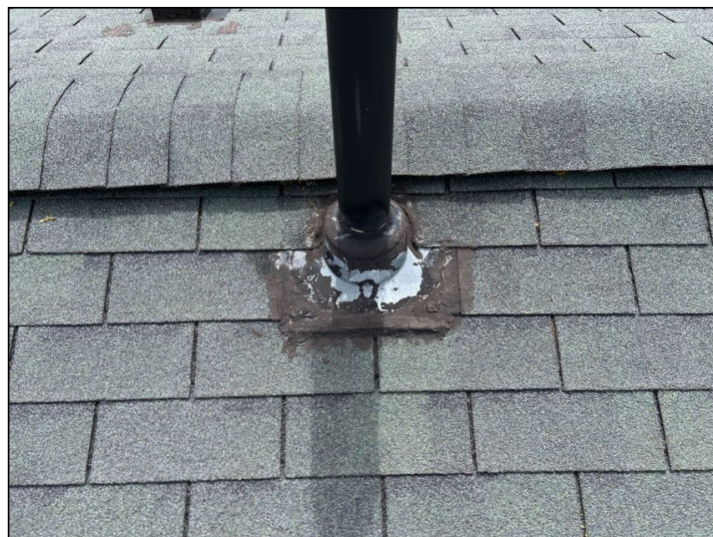
Flex seal/roof tar noticed at roof penetrations. Maintenance may be required to prevent leaks.

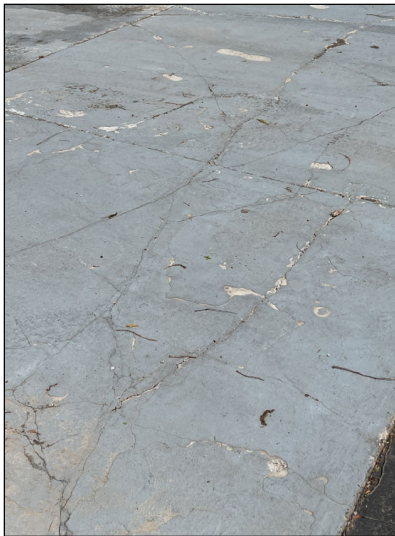
IMPROVE: Typical cracking was observed at the concrete surfaces. Further deterioration will occur as water expands and contracts from freeze and thaw cycles. Recommend sealing the cracks to prolong the life of the concrete.

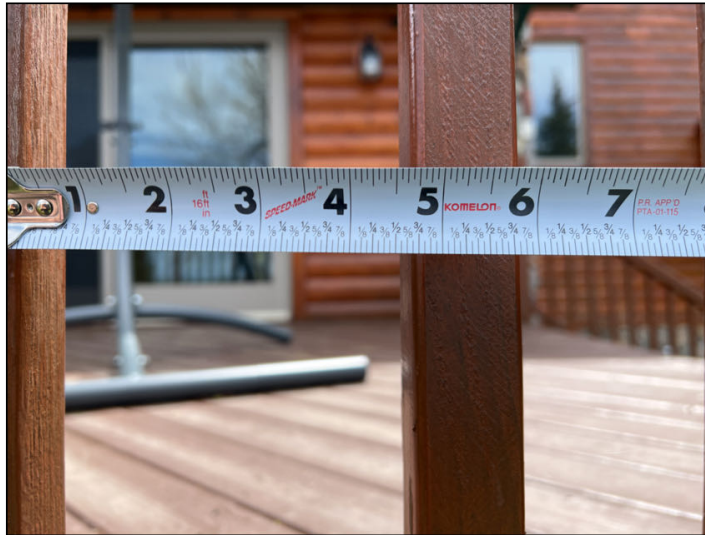
Spindle spacing exceeds the 4 inch spacing which is considered safe by today's child safety standards.

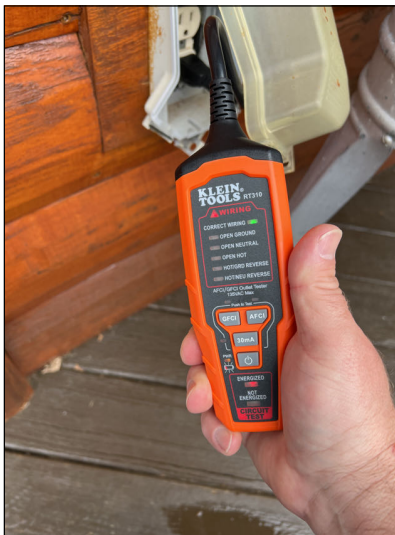
The exterior deck outlet GFCI did not shut of when tested, have a qualified electrician replace it.

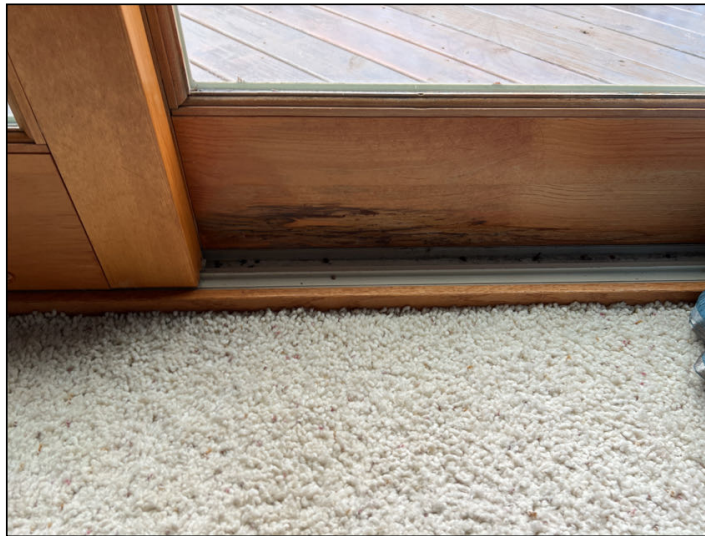
Wood deterioration observed at upstairs office door. Suggest repairs/replacement as needed or to monitor condition.

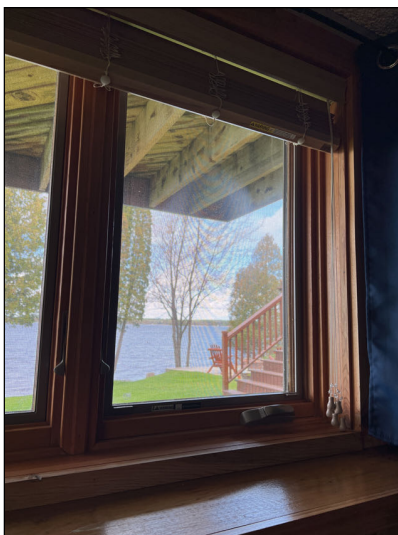
Fog/condensation observed in thermopane windows. This is an indication of a failed seal.
Recommend review for repair or replacement as necessary.

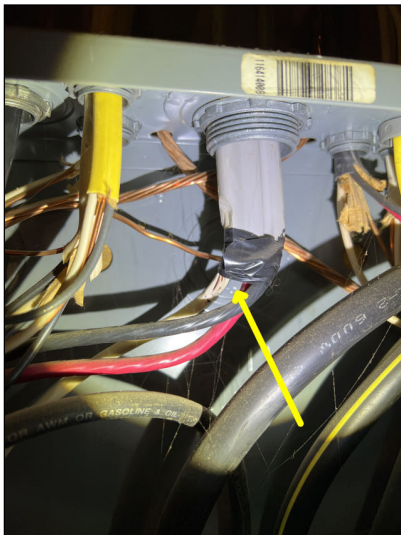
Nicked or bare wire inside of panel

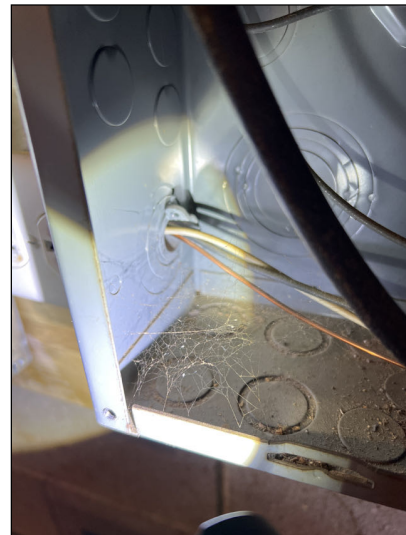
Broken/missing strain relief inside panel.

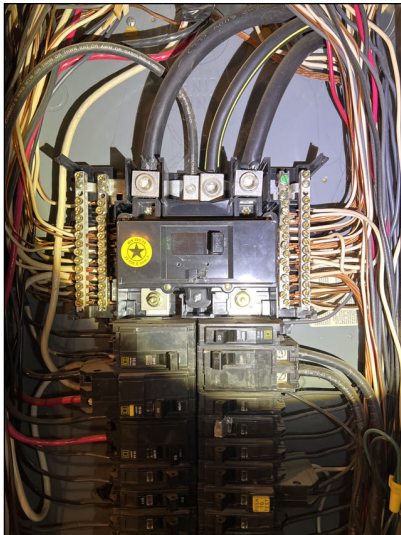
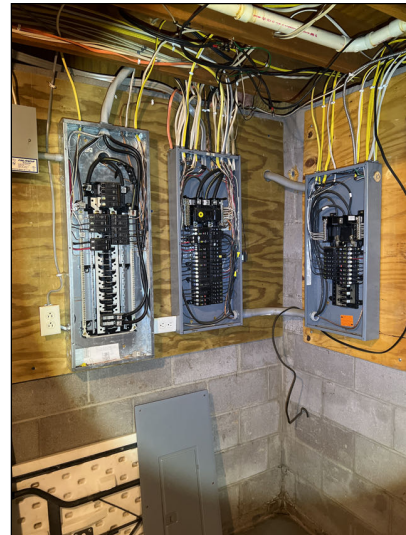
Grounding / Bonding questionable. Multiple wires under same lug

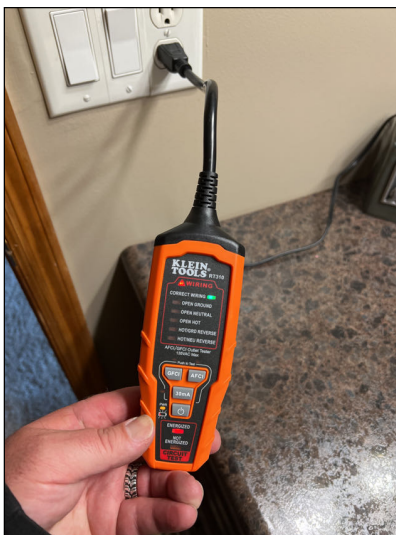
No GFCI protection present in upper floor bathroom, suggest installing GFCI protected receptacles for safety

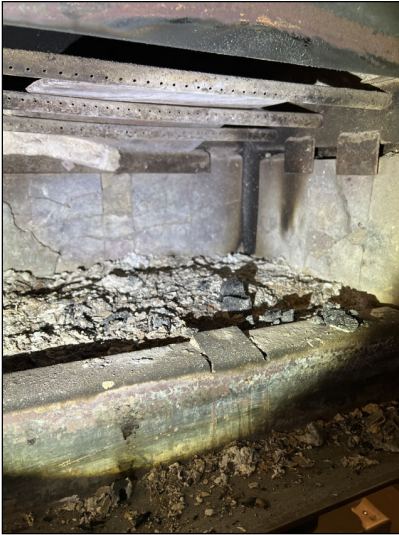
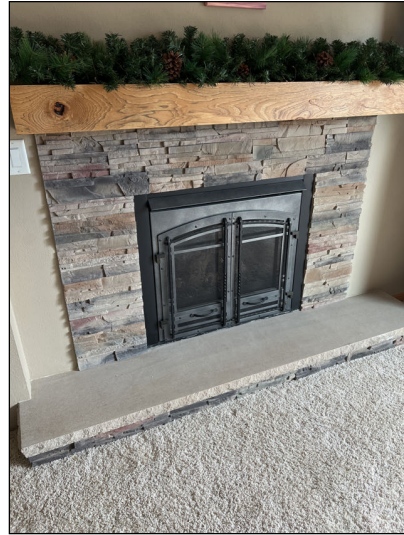
Small cracks/ crumbling present in the firebrick of the basement wood stove

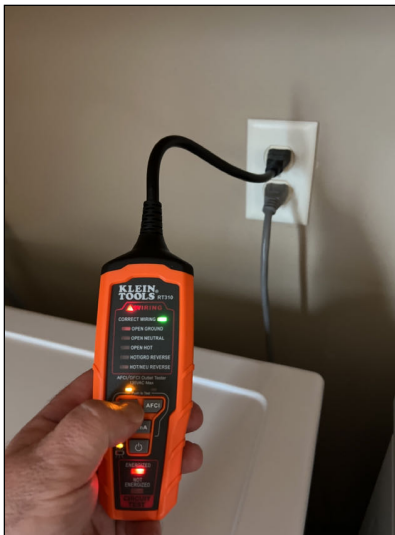
Recommend upgrading All receptacle to GFCI protection within 6 feet of all potential wet locations.

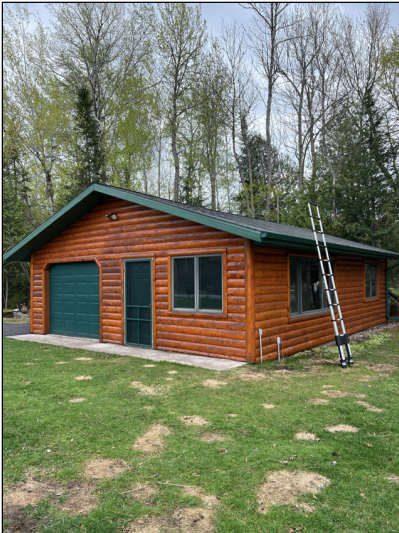
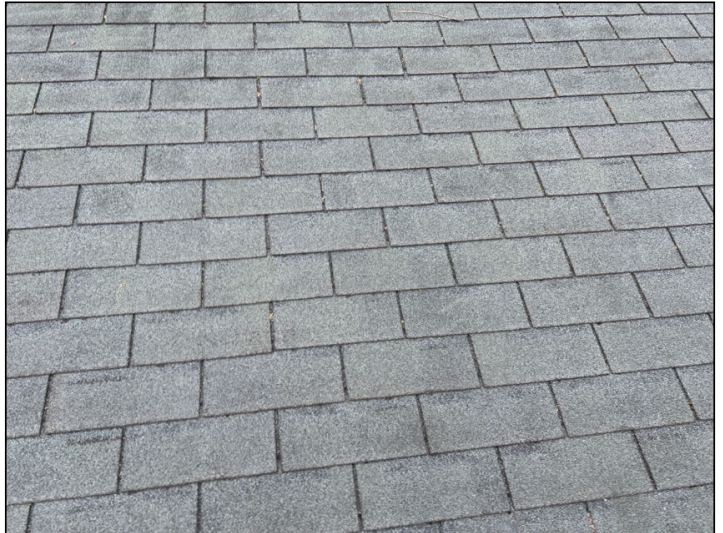
- The shingles showed signs of granular loss. This happens when the granules come off the surface of the shingles and the shingle deteriorates faster due to the asphalt substrate being exposed to the elements. Granular loss happens with the aging of shingles or can happen by walking on the roof or shoveling the roof surface.

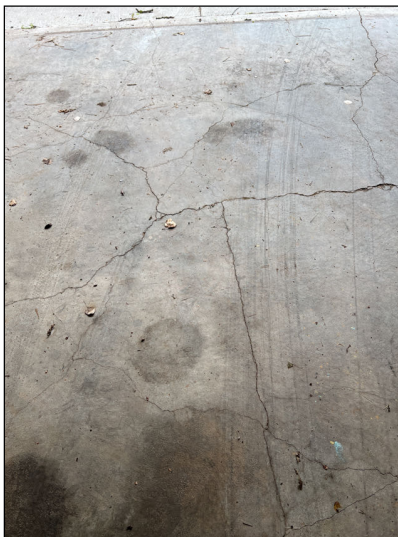
Common cracks noted.

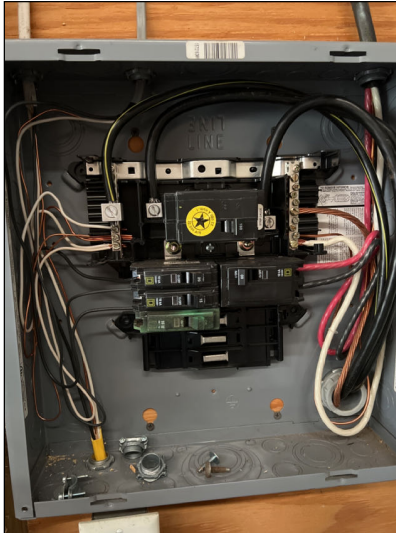
Bonding issues in electrical panel. Neutral and ground wires bonded together. Multiple wires under one lug.
